**SURFACE TREATMENT OF HIGH PERFORMANCE
MARINE ALLOYS TO ENHANCE CREVICE CORROSION
RESISTANCE IN CRITICAL SEAWATER APPLICATIONS**

**Final Report on the Benefits and
Limitations of Electropolishing and
Cerium Surface Treatments
Contract No. N000144-95C-001**

Robert M. Kain
LaQue Center for Corrosion Technology, Inc.
Post Office Box 656, 702 Causeway Drive
Wrightsville Beach, NC 28480
(910) 256-2271 • FAX (910)256-9816

January 1998

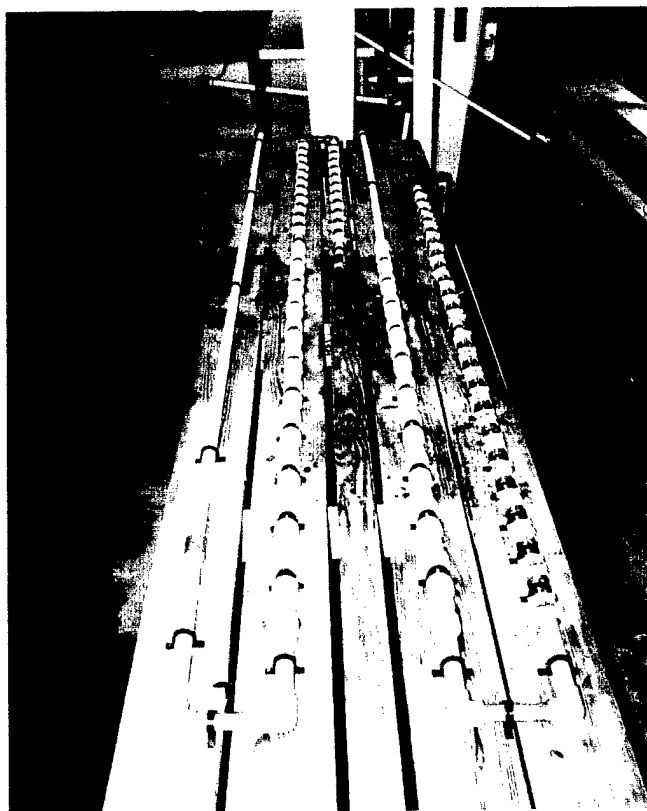
Figure 5. Overall view of completed test assembly comprising pipe specimens with vinyl sleeves (right and rear) and PVC compression fittings with rubber glands (center foreground).

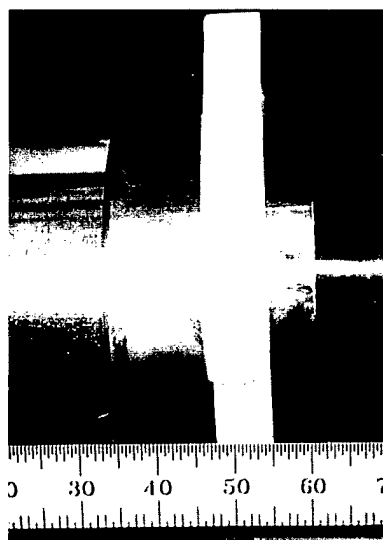
Figure 11. In-situ views showing crevice corrosion incurred by two as-produced pipe specimens, l) No. 017 and r) No. 018, during a 180-day exposure to cold, natural seawater with vinyl sleeve crevice formers.
